The Schooner Metropolis: A Field Report

Written by: C. Golden, D. Hendrix, K. Jaroh

NAS II Field Report

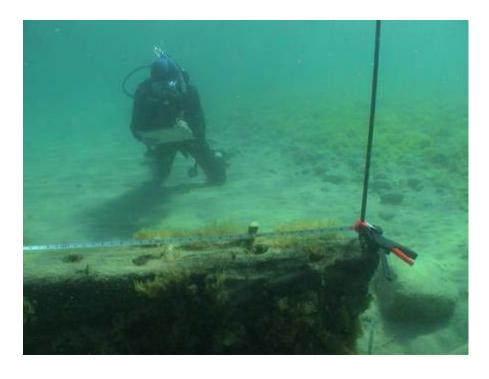
Figure 4 Survey marker (K. O'Meara) pictured: D. Hendrix

The procedure to conduct the offset survey was as follows: On the first day, two permanent survey markers were installed at either end of the wreck, at the center of the line of the keel (Fig 4). The survey markers were steel reinforcement rods, which were driven into the bottom with a hammer. The markers were installed about four inches away from the end of the keel at each end of the wreck. Care was taken to avoid touching the keel with the survey markers. A tape measure was then attached to one of the survey markers and laid out along the top of the keel to the second survey marker.

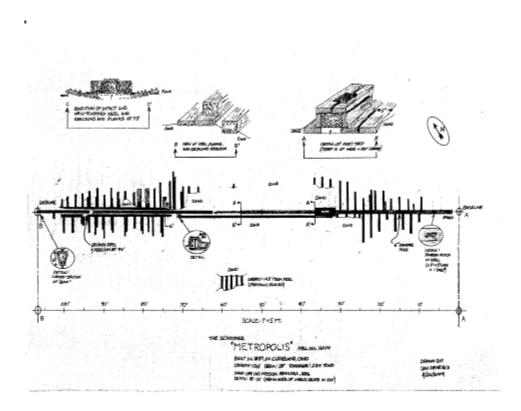
Fig:5 Site Drawing (D. Hendrix)

After the field work was completed, the field notes and measurements taken during two days of diving were compiled and a composite drawing of the wreck was created. This drawing is shown in Fig.5. On September 20, 2009 Chris Doyle visited the site and took numerous still photographs of the Metropolis to use in the creation of a composite photographic image of the entire wreck.

This drawing shows the keel, keelsons, visible ribs and planks, and includes detail sketches and dimensions. Many of the ribs and planks are broken off, missing, or are covered with sand. The manual survey (Fig. 5) taken using the offset method measures the site at 107 feet (32.61m) and the sector scan sonar (Fig. 6) scales the site to 105 feet (32.0m). This discrepancy is acceptable due to the variation of the sand covering the wreck. Excavation was not possible due to state law.

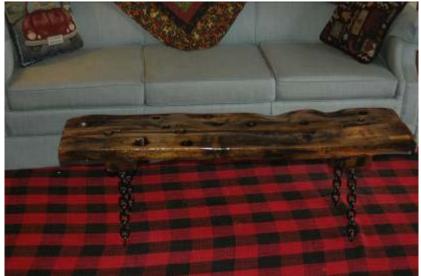
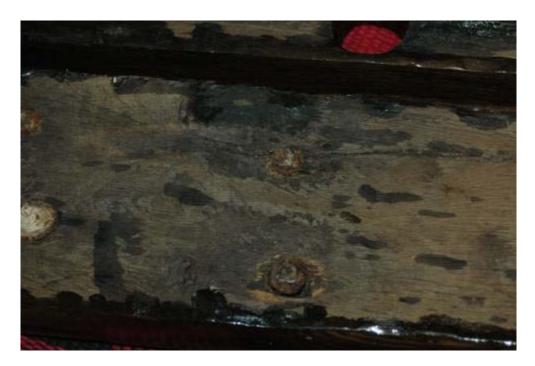
Figure 7: Coffee table made from planks of the Metropolis (C. Golden Photo)

Figure 7.2: Unpreserved under side of coffee table note the Iron peg heads (C. Golden Photo)

In the 1960s it became fashionable in the Great Lakes area to utilize anchors, chain, fixtures and white oak lumber recovered from shipwrecks to decorate homes and businesses. A cottage industry developed in northern Michigan to recover these items from the wrecks and to fabricate tables, bars, chairs and wall decorations. (Figure 7.1&7.2) The historical value of the wrecks was not yet recognized, and so many of them were stripped and plundered for profit. The Metropolis is a case in point.

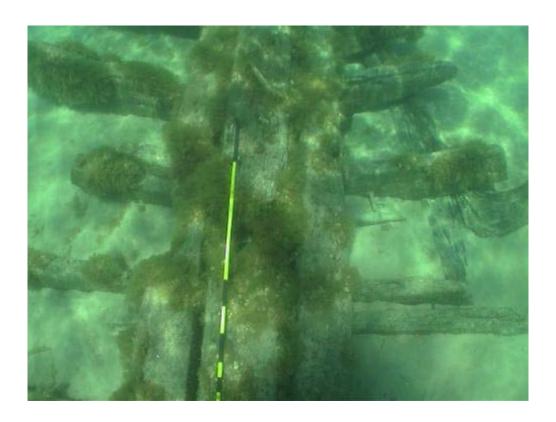
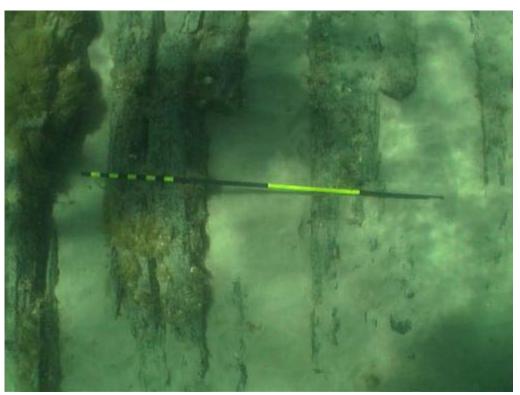
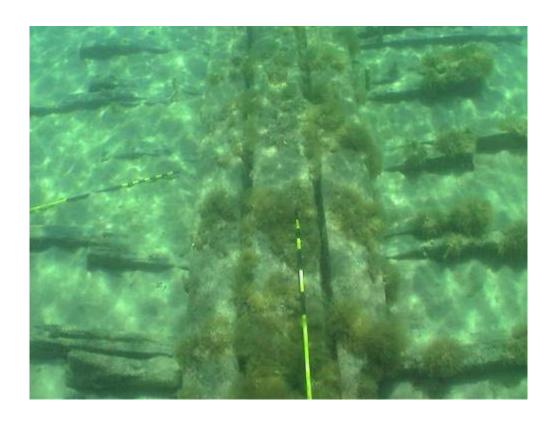
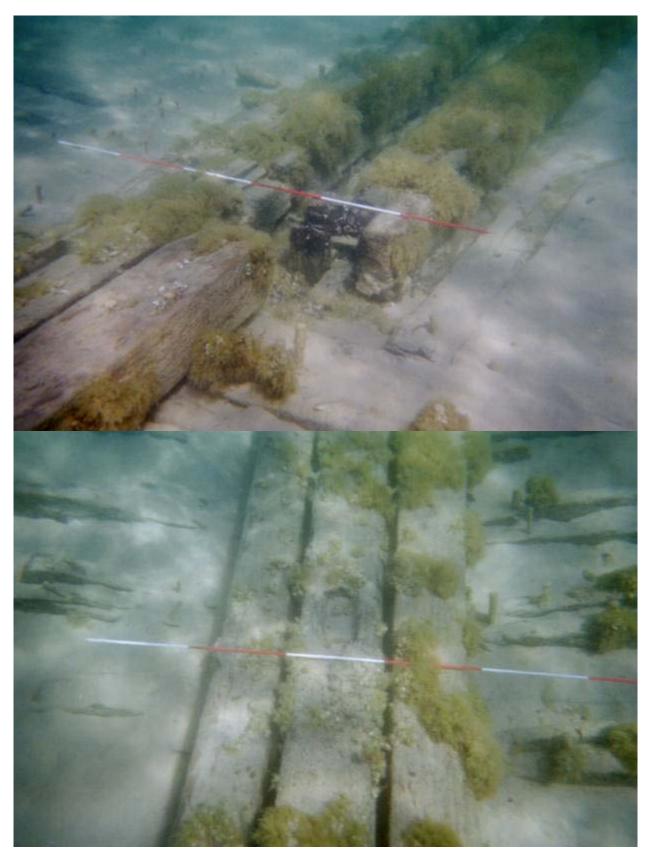
Appendix C: Photos Scale shown is 1 m

Most of the hull planks from the Metropolis have been removed. Only the spikes remain, sticking out of the sandy bottom. All of the fixtures, rigging, chain, etc. is gone. Some of these items may have been removed many years ago or may have been swept away by storms and ice. The deep portion of the Metropolis wreck was separated from the shallow portion during a salvage attempt, but it was lost in deep water and remains there today. A deflated lift bag is still attached to the deep portion of the wreck (See appendix C).

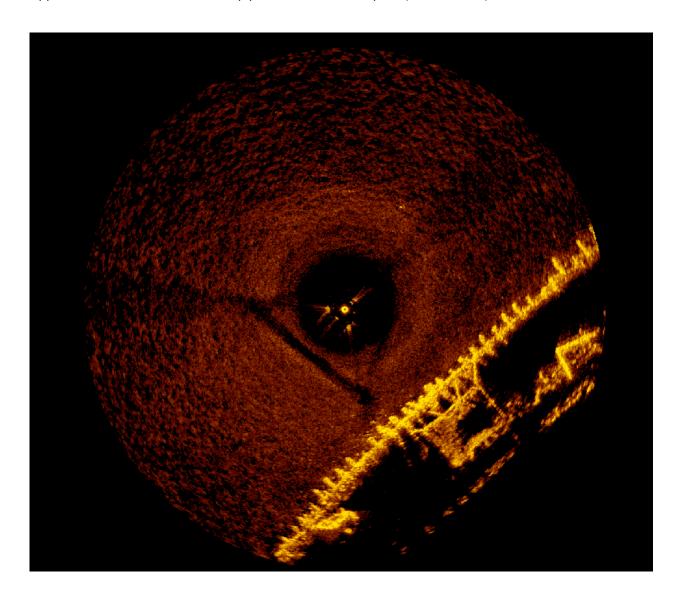
Appendix F: Sector Scan of the Deep portion of the Metropolis (Brian Abbott)

A second section of the wreck rests farther offshore in approximately 120 feet (36.5m) of water and is therefore beyond the scope of this preliminary study. As discussed earlier in this report, the Metropolis ran aground in shallow water in a November storm in 1887. The wreck was determined to be unsalvageable by the owners and so the entire ship was abandoned at that time.

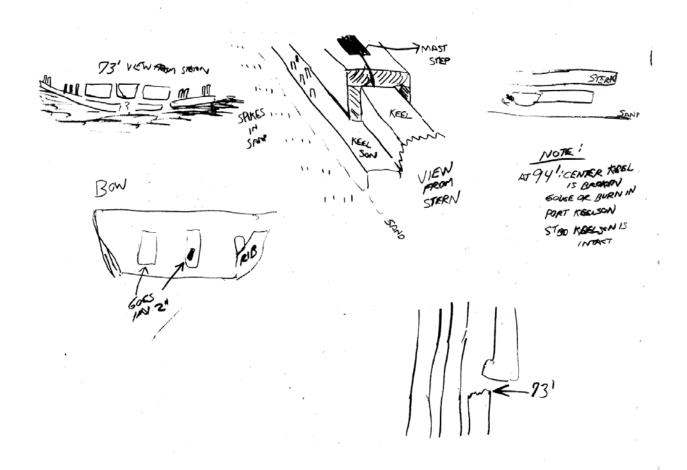
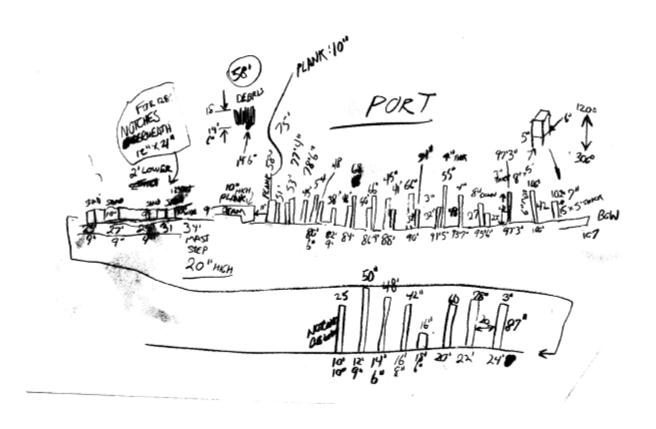
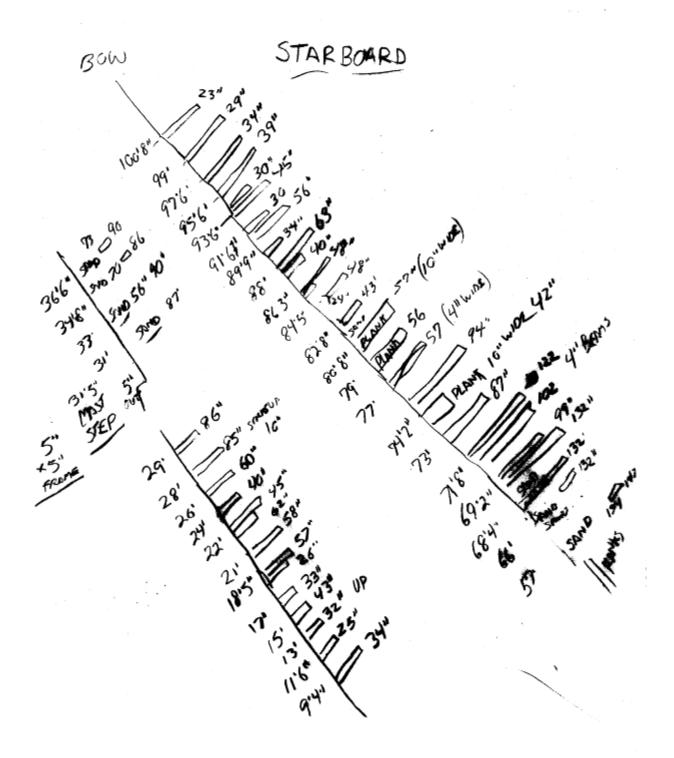
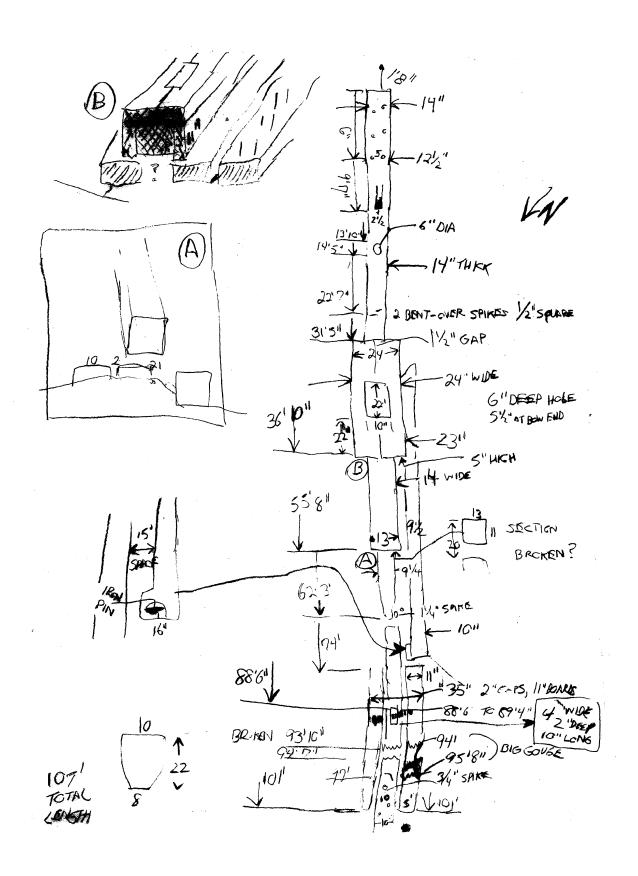
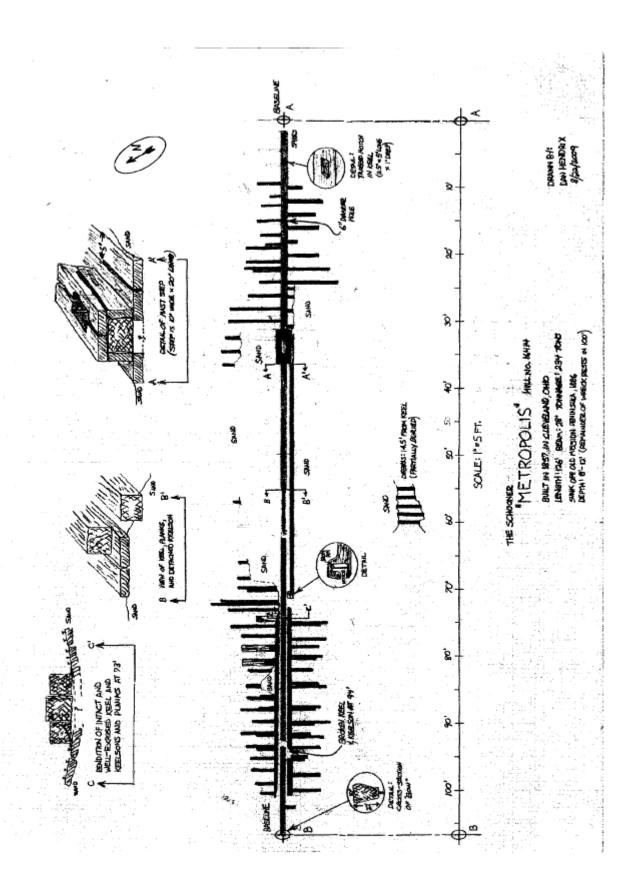
Appendix G: Notes and Drawings

tape that was laid out on top of the keel. A second, shorter tape was used to measure the dimensions of the keel structure at selected points along the first tape measure. One diver held the short tape at the center of the keel on the first tape. The second diver played out the tape and noted the distance to points on the keel and keelsons. The first diver then wrote down both measurements and made a sketch of the keel and keelsons. Both divers then repeated the procedure and moved along the keel from one end of the wreck to the other. All measurements were made perpendicular to the keel. The field notes and measurements taken by the divers are included in appendix to this report.

On the second day of the survey (July 29, 2009), the same offset survey process was repeated. This time all of the ribs and planks on either side of the keel were measured. Again the divers started the survey at the beginning of the measuring tape that was laid out on top of the keel. The distance out to the ribs was measured, as well as the dimensions of each rib. A sketch was made showing the ribs, their dimensions, and their relationship to the keel. All measurements were made perpendicular to the keel. The field notes and measurements taken by the divers are included in Appendix G to this report.
